CORPS OF ENGINEERS OMAHA NE
HARDENED WALL TESTS.(U)
APR 78

(6) HARDENED WALL TESTS.

Corps of Engineers ✓

(11) 21 Apr 1978

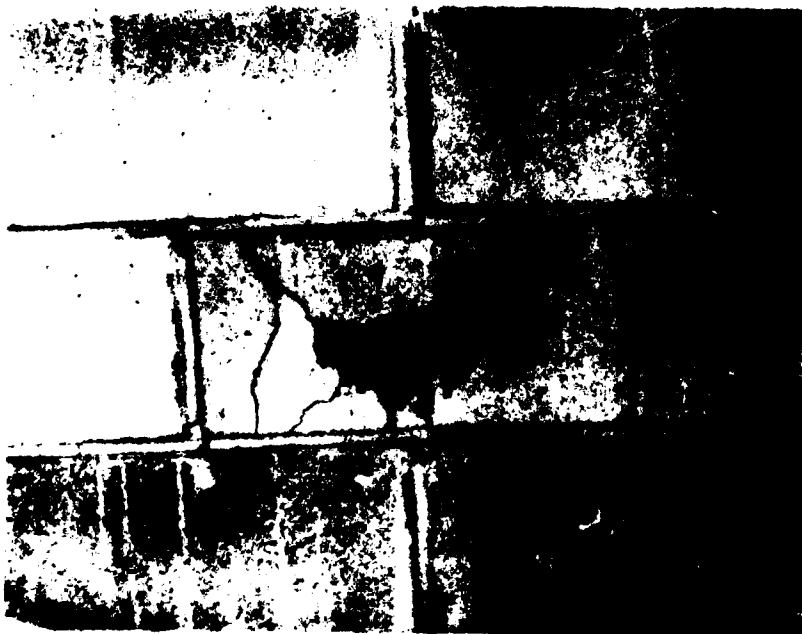
1-17

1-17. Wall #6.
Additional
4-shot burst
penetrated first
CMU and face
shell of second
CMU. Did not
penetrate back
shell of second
CMU.

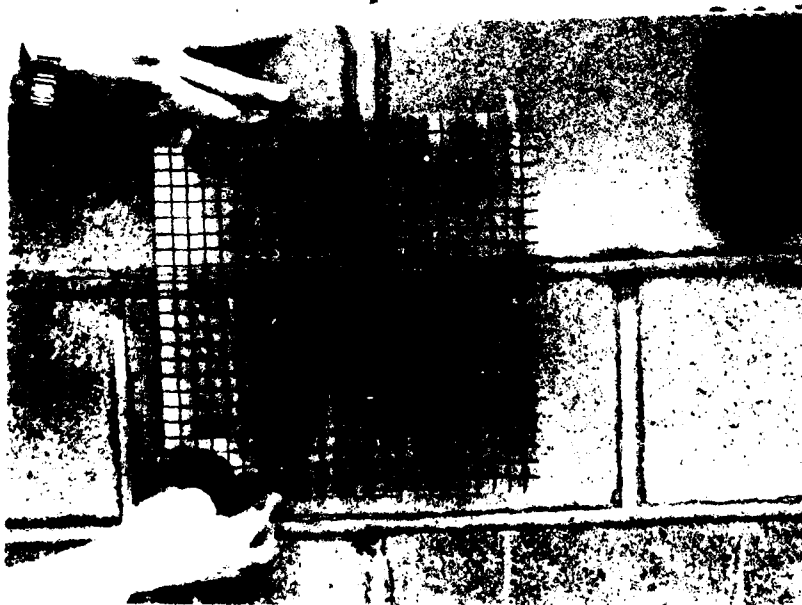
1-18

1-18. Wall #8.
First shot
[see #2-19 and
#2-20 also].
Shot hit near
web of CMU.
Penetrated face
shell of first
CMU but did not
penetrate back
shell. Spall
3-1/2 In. Dia.
Hole 1 In. Dia.

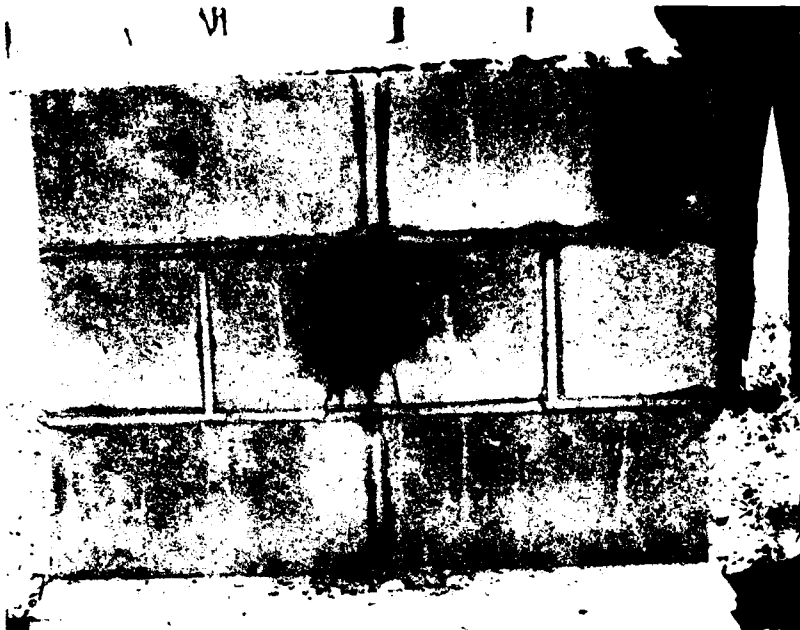
1-20

1-20. Wall #8.
4-shot burst
penetrated
first CMU and
face shell of
second CMU. Did
not penetrate
back shell of
second CMU.

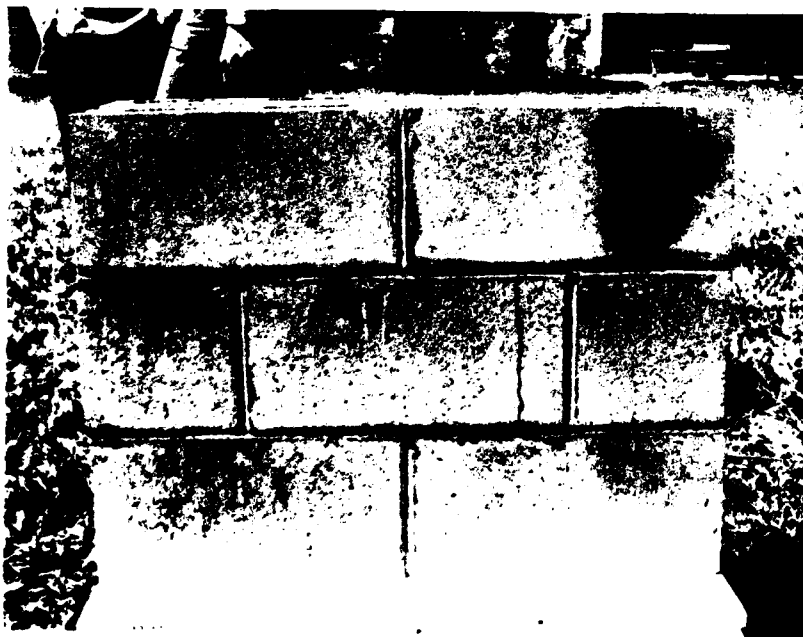
1-19

1-19. Wall #8. 4-shot
burst shows
crack in back
shell of second
CMU.

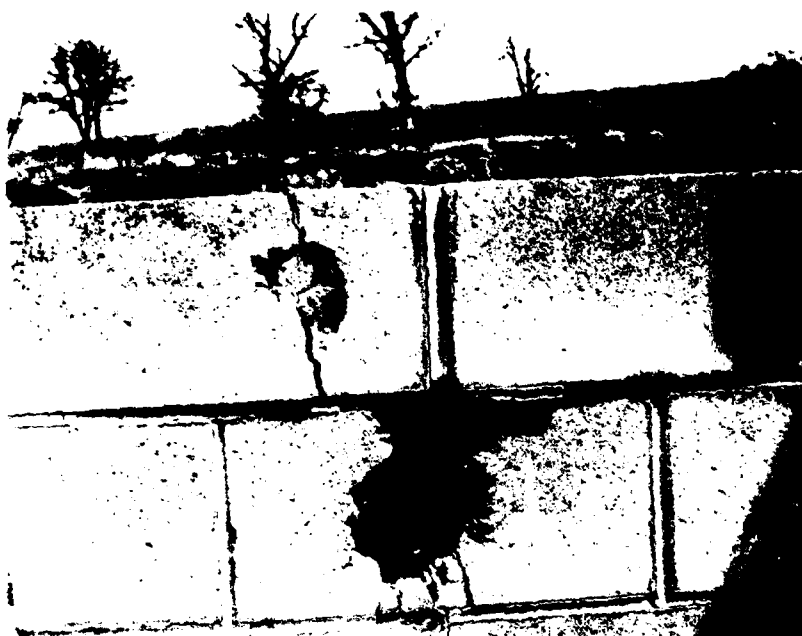
2-19

2-19. Wall #8.
Single shot
after 4-shot
burst.
[See 2-20.]

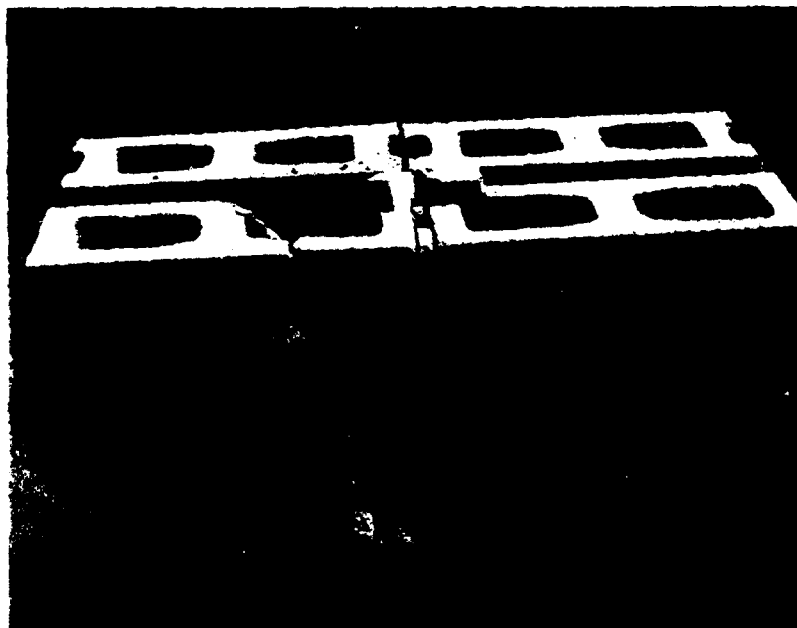
2-20

2-20. An additional
shot was made
at this wall
in between webs.
Penetrated first
CMU but did not
penetrate face
shell of second
CMU.

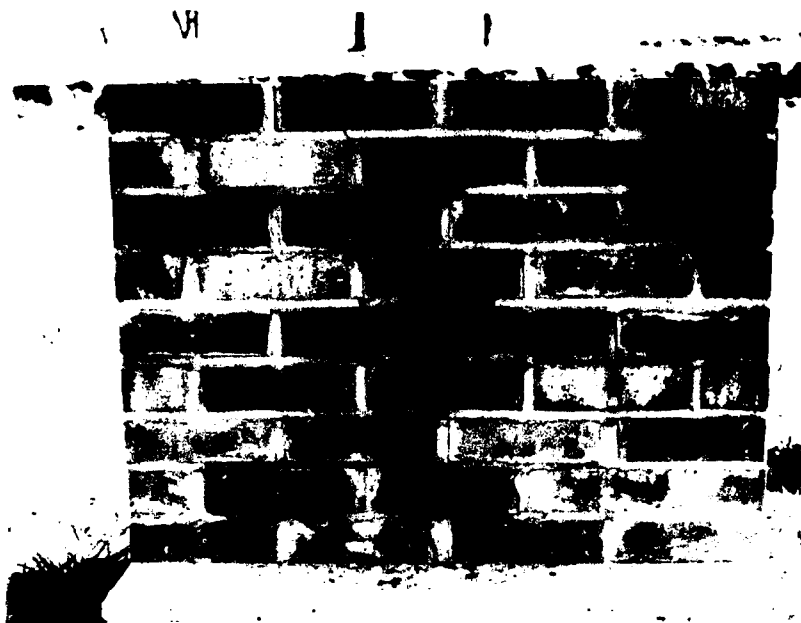
2-2

2-2. Wall #10.
4-shot burst.
[See 2-1.]

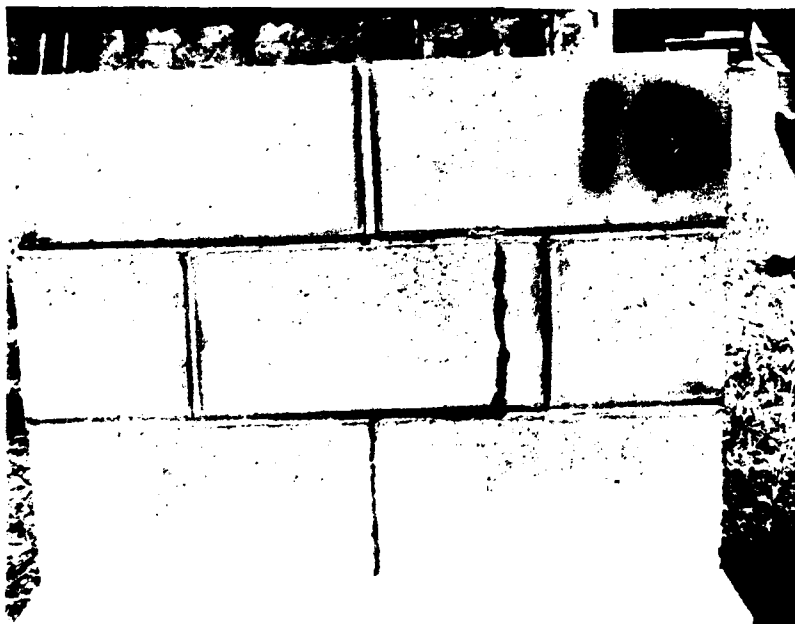
2-1

2-1. Penetrated
brick and face
shell of CMU.
Cracked back
shell of CMU.

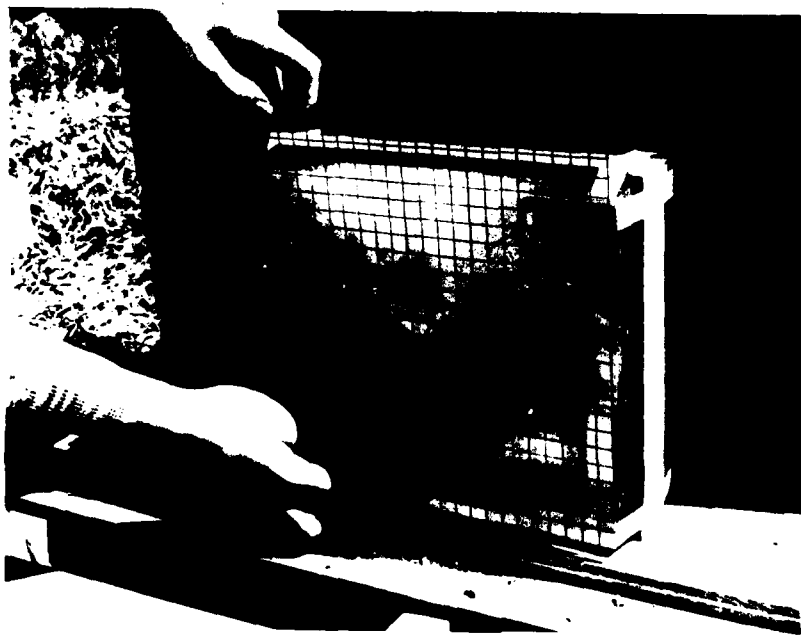
2-4 Glass Sample.
First shot.
Penetrated approx.
0.7 inch. Spall,
3-inch. Hole,
2-inch. Back of
glass was spalled
off.

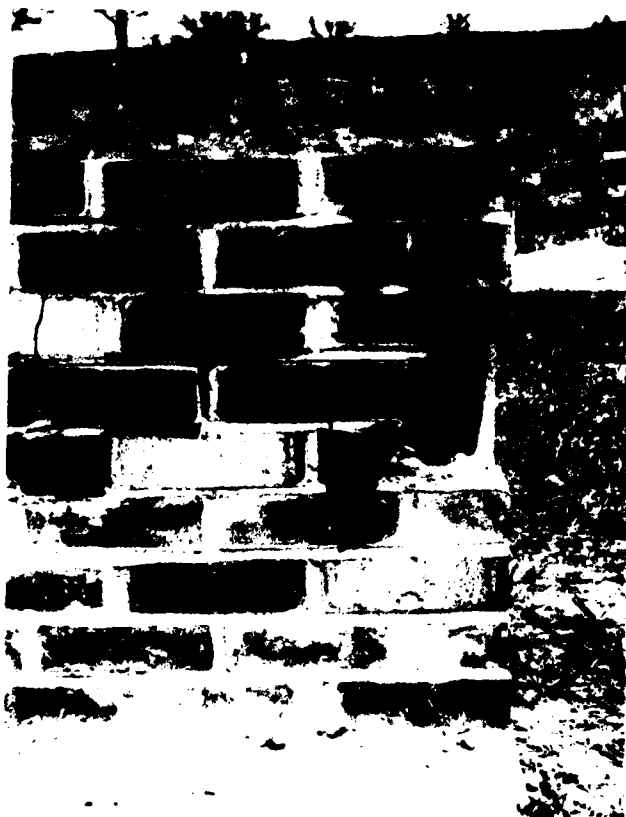
3-17

3-17. Wall #12.
Single shot from
75 feet. Hit
near edge and
broke out entire
brick but did not
penetrate face
shell of CMU.

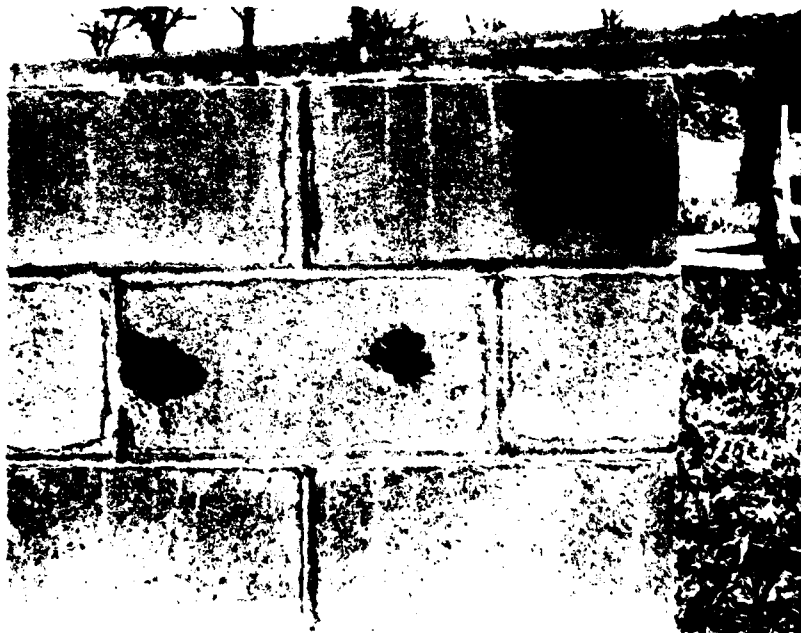
2-16

2-16. Wall #14.
Two single
shots approxi-
mately 8 in.
apart. First
shot on left
penetrated
face shell but
did not pene-
trate back shell.
This shot hit a
portion of the
web. Second
shot hit between
webs and pene-
trated entire
wall.

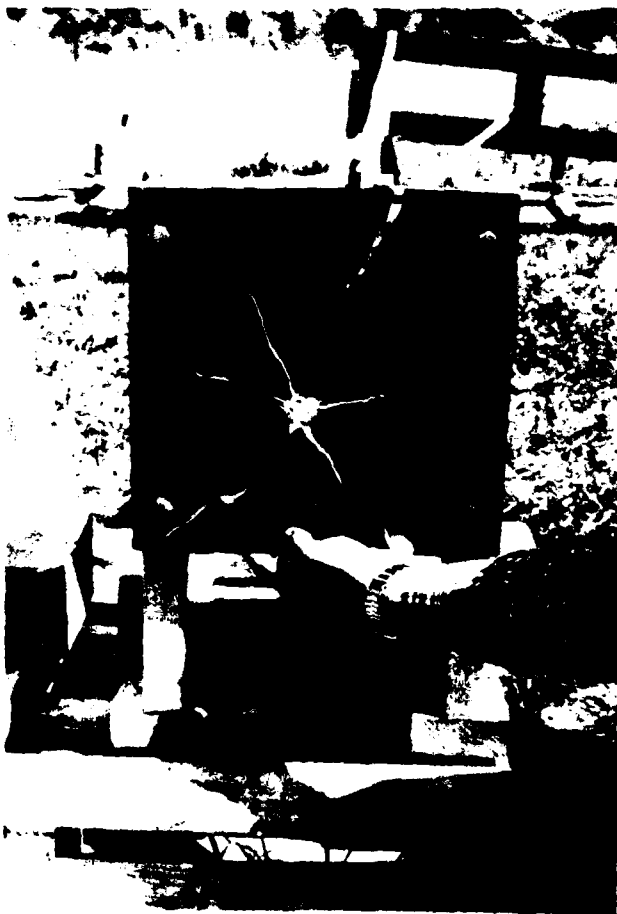
1-36
(colored)

1-36 (colored).
#19, shows bullet
went through.

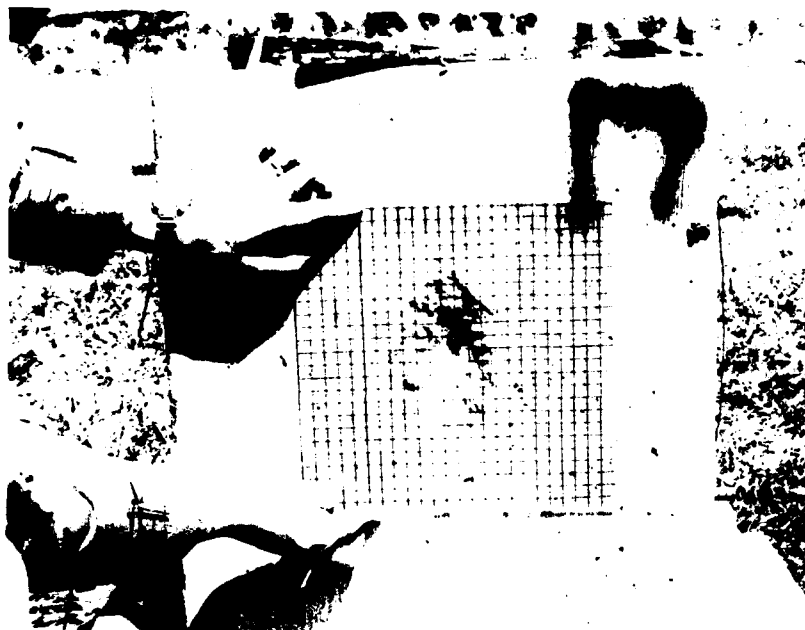
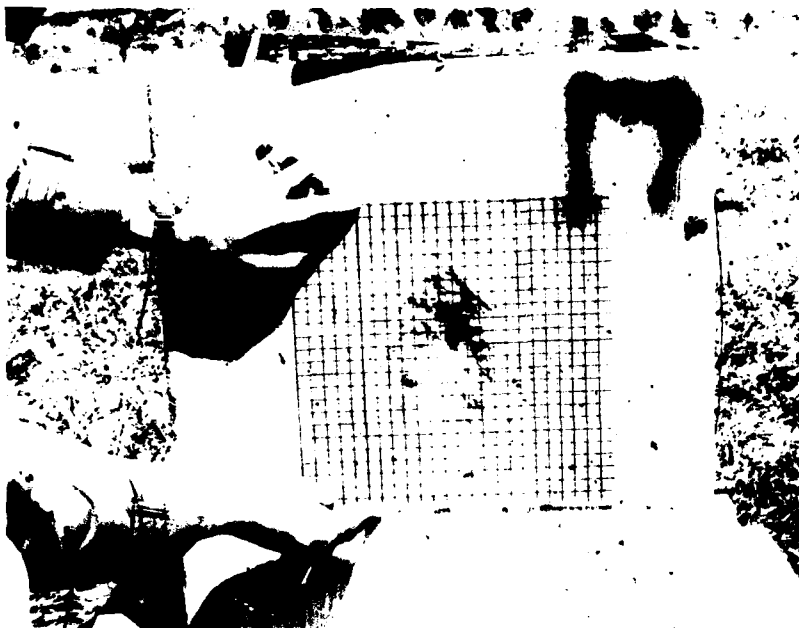
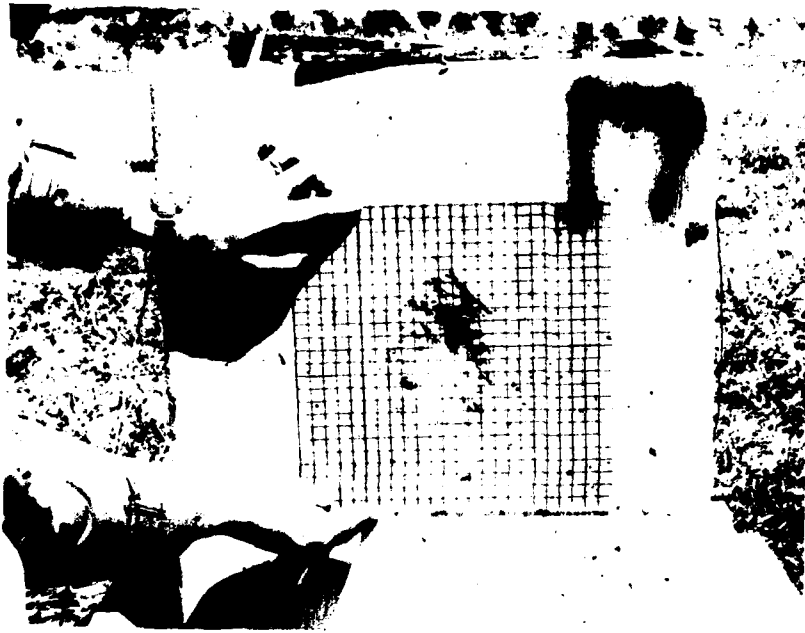
3-6

3-6. Wall #17. Single shot. Did not penetrate. Spall, 6 inches. Depth, 1.601 in.

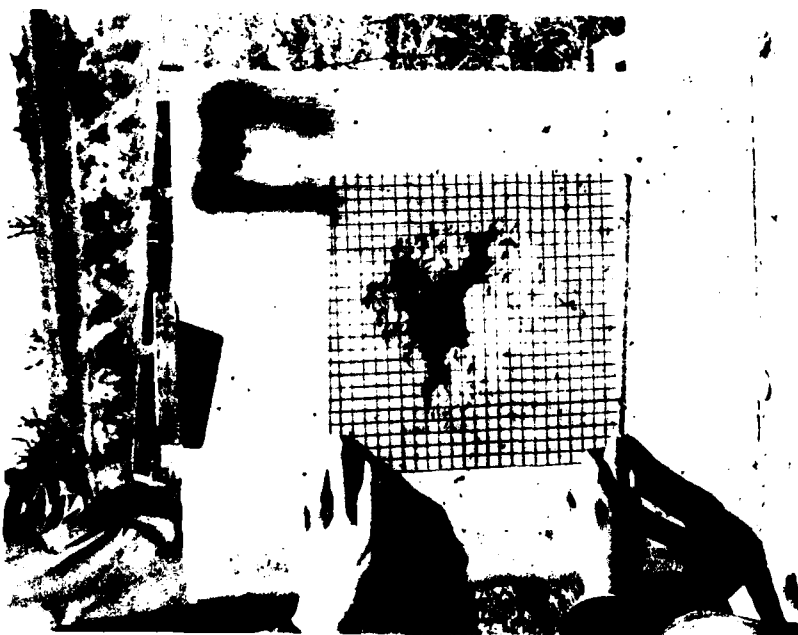
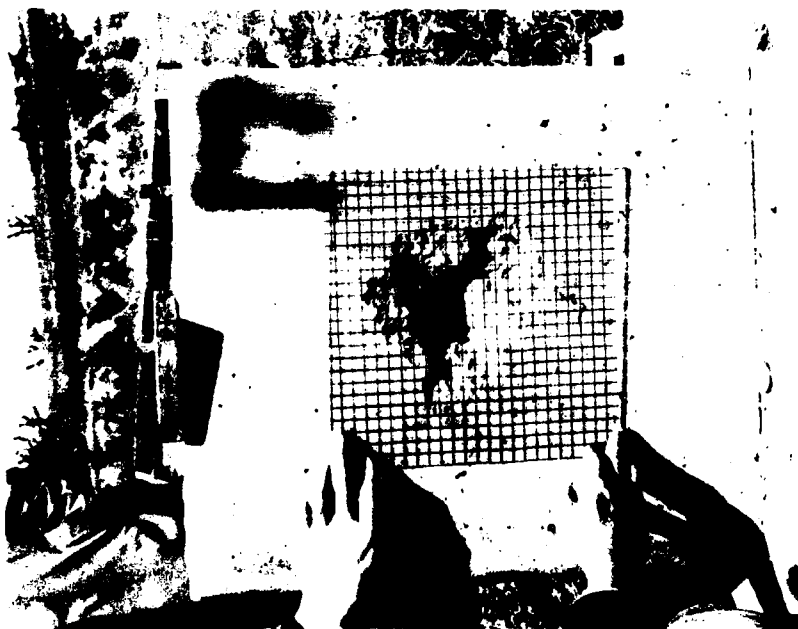
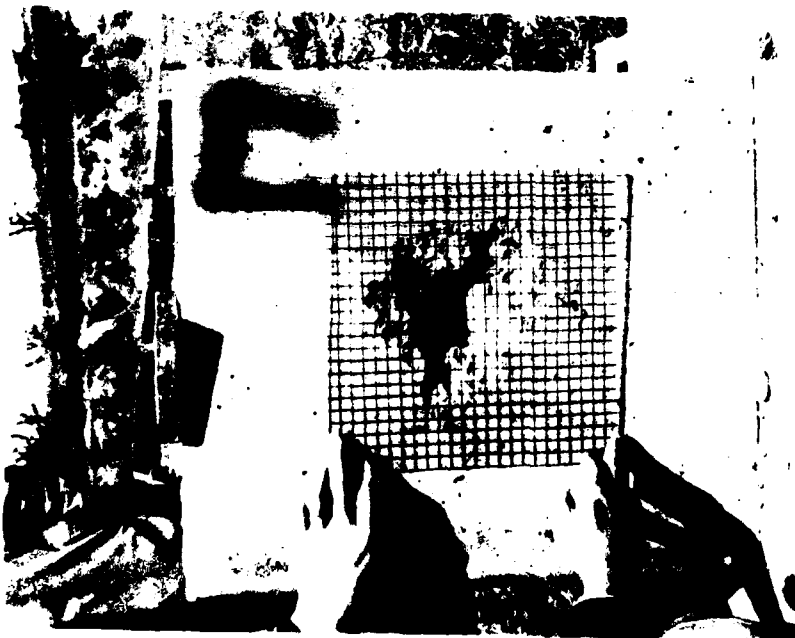
3-7

3-7. Wall #17. 4-shot burst. Did not penetrate. No cracks in rear face. Depth of penetration, 2.775 inches.

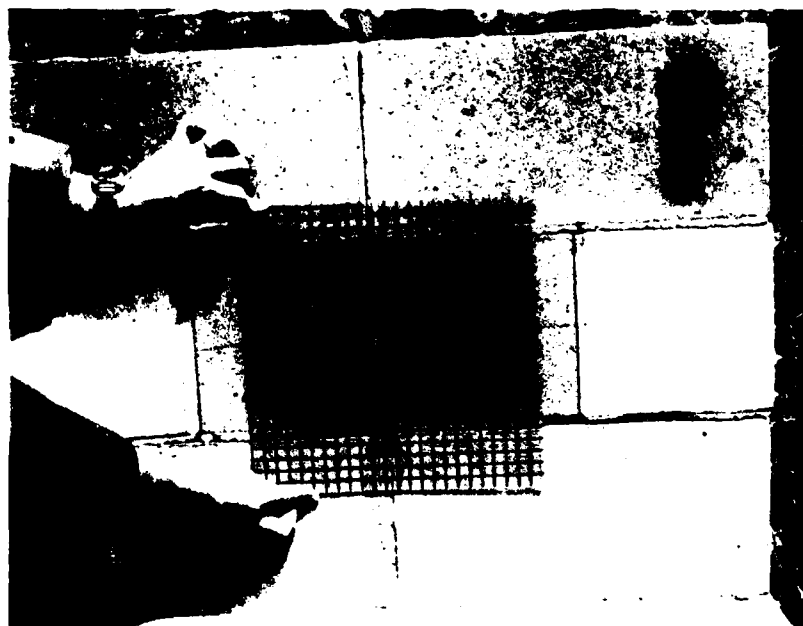
3-8

3-8. Wall #1. Single
shot. Penetrated
4-inch CMU and
spalled 6-inch
CMU.

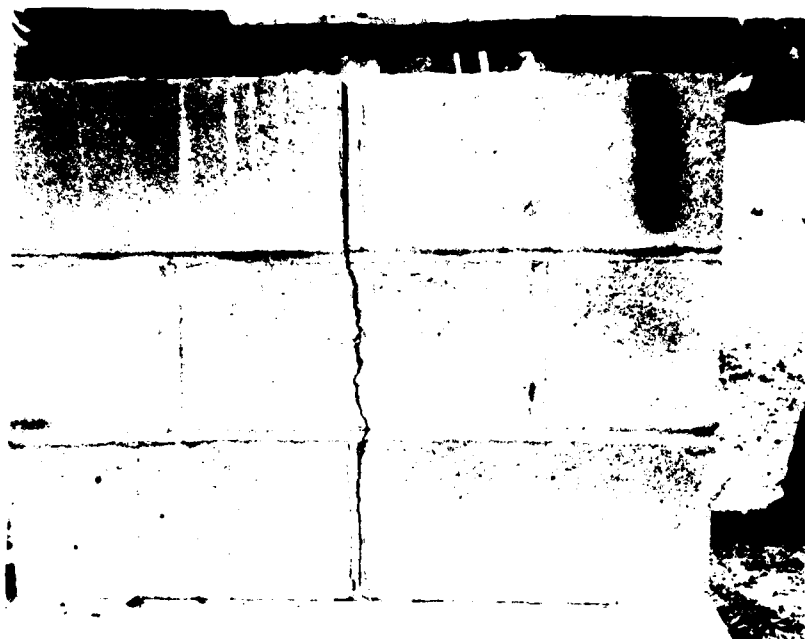
3-9

3-9. Wall #1. 4-shot burst penetrated 4-inch CMU. Did not penetrate 6-inch CMU. Put 7" spall in 6-in. CMU.

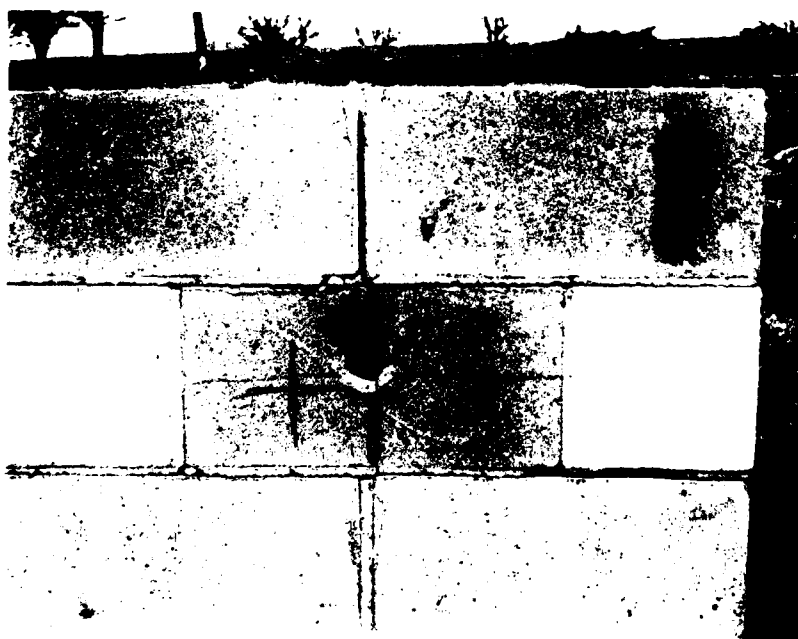
3-10

3-10. Wall #1. 4-shot burst. Crack in back of 6-inch CMU.

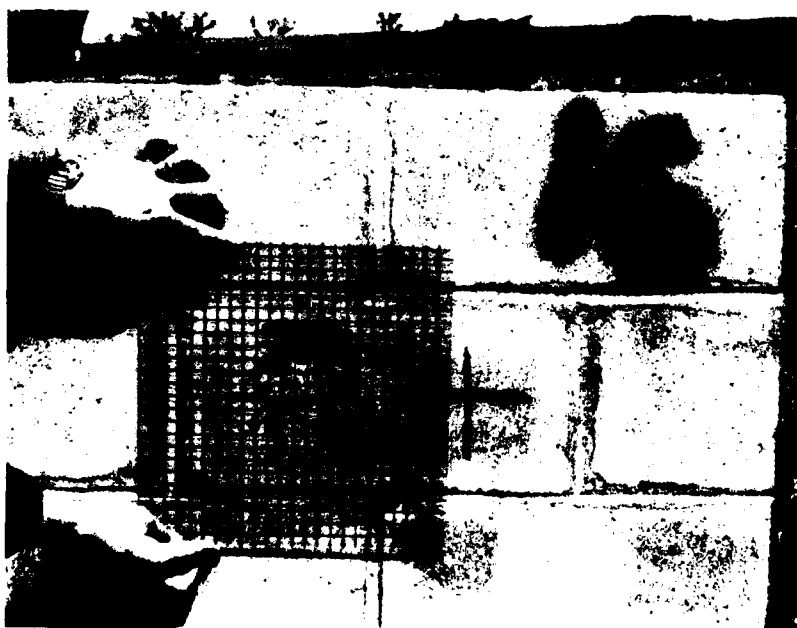
3-11

3-11. Wall #16. Single
shot. Penetrated
face shell. Did
not penetrate back
shell. No cracks
in back of wall.

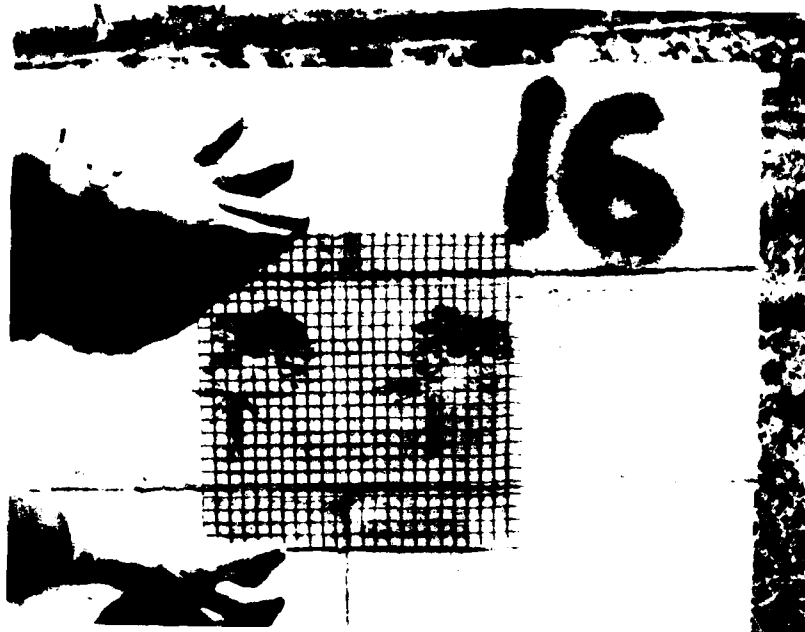
3-12

3-12. Wall #16.
Single shot
approximately
8 inches from
first shot.
Same results as
previous shot.

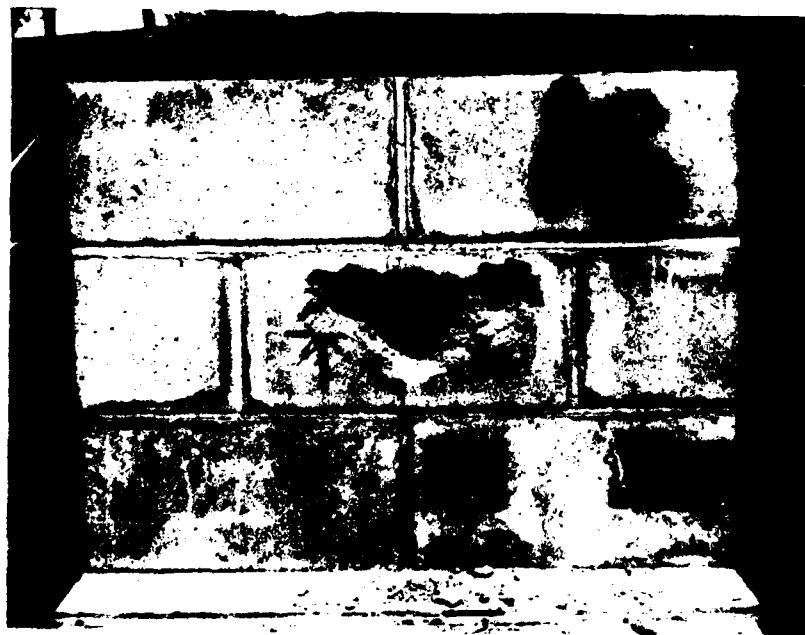
3-14

3-14. Wall #16.
4-shot burst.
Penetrated
entire wall.

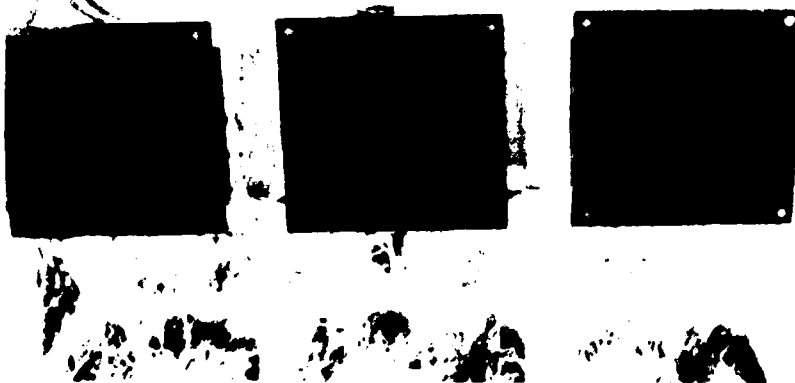
4-2

4-2. Shows double plates above with a single shot at each plate. Single shot went through the first plate and did not penetrate the second plate in all cases.

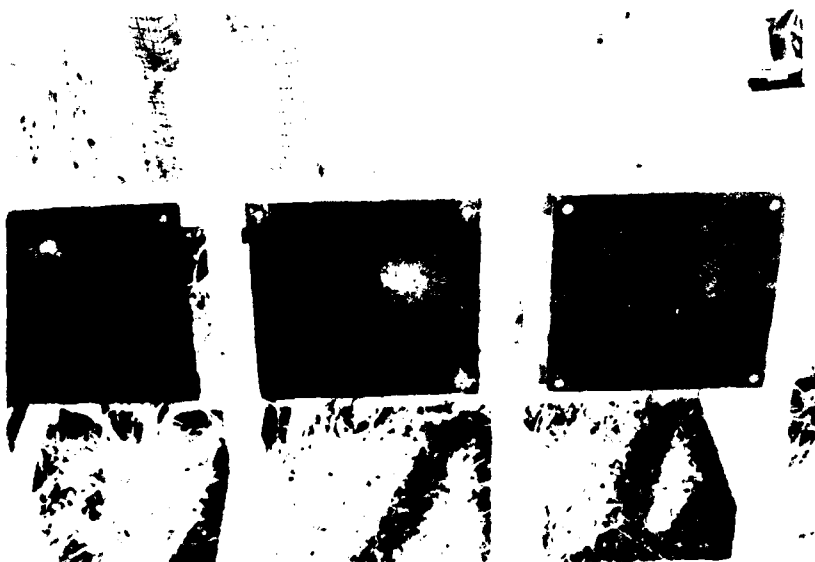
5-1

5-1. View of single plates with a single shot fired at each. Left-most plate is 1/4-in. hardened steel (Astralloy) Brinell Hardness = 356. Single shot did not penetrate plate. It put a bulge in back side of plate. Center plate is 3/8-in. hardened steel (Astralloy) Brinell Hardness = 299. It

did not penetrate or put a bulge in back side. Right-most plate is 5/8-in. A-36 steel. Single shot did not penetrate, but did put a large bulge in back side of plate. Appeared to come very close to penetrating.
